## Anastasian Wall Project 2005

Jim Crow, Newcastle University

### Silivri (Selymbria)

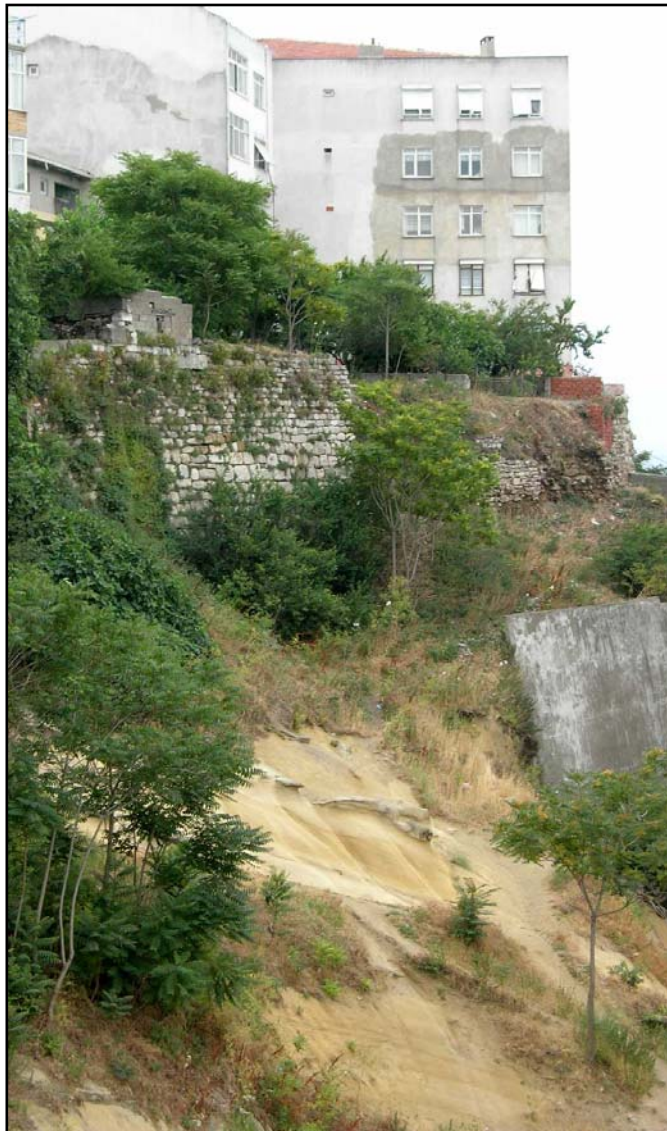
**Fig. 1. The Byzantine Harbour Walls of Silivri, set amongst modern apartments.**

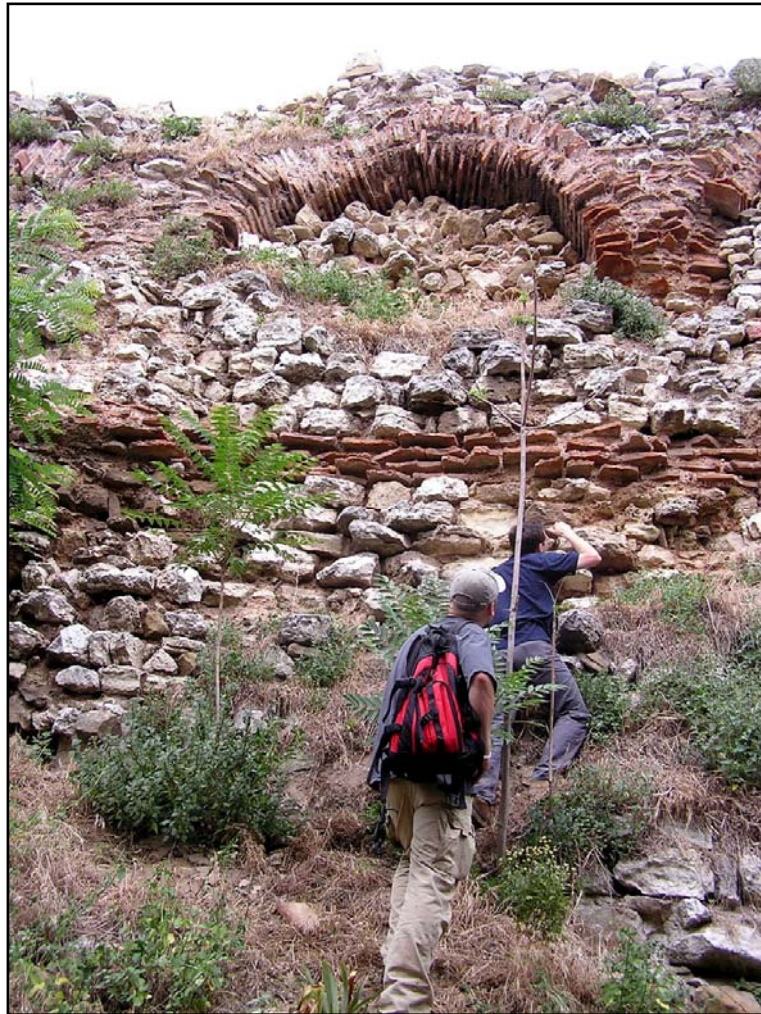
**Fig. 2. Silivri: brick arcades on the harbour walls.**

To the west, overlooking the harbour, the walls were constructed near the top of the hillside with a distinctive sequence of brick arcades (Figs 1 & 2). The curtain wall was cut into the sandstone bedrock which has been severely eroded on the downslope side. Once again two main phases of brick stamps were seen in the vaulting, the outer belonging to the early-mid fifth century and later, inner vaults dating from the sixth century. It was possible to recognise 11 continuous rows of arcades, 2.85 m wide, before later works and restoration intervened. The extensive use of blind brick arcades found on both the north and west curtain walls at Silivri was a characteristic of other major fortifications dateable to the fifth century in the Balkans - at Thessalonike and Perinthos, at Antioch in the East and on the sea-walls of Constantinople (although the date of the latter remain contested).

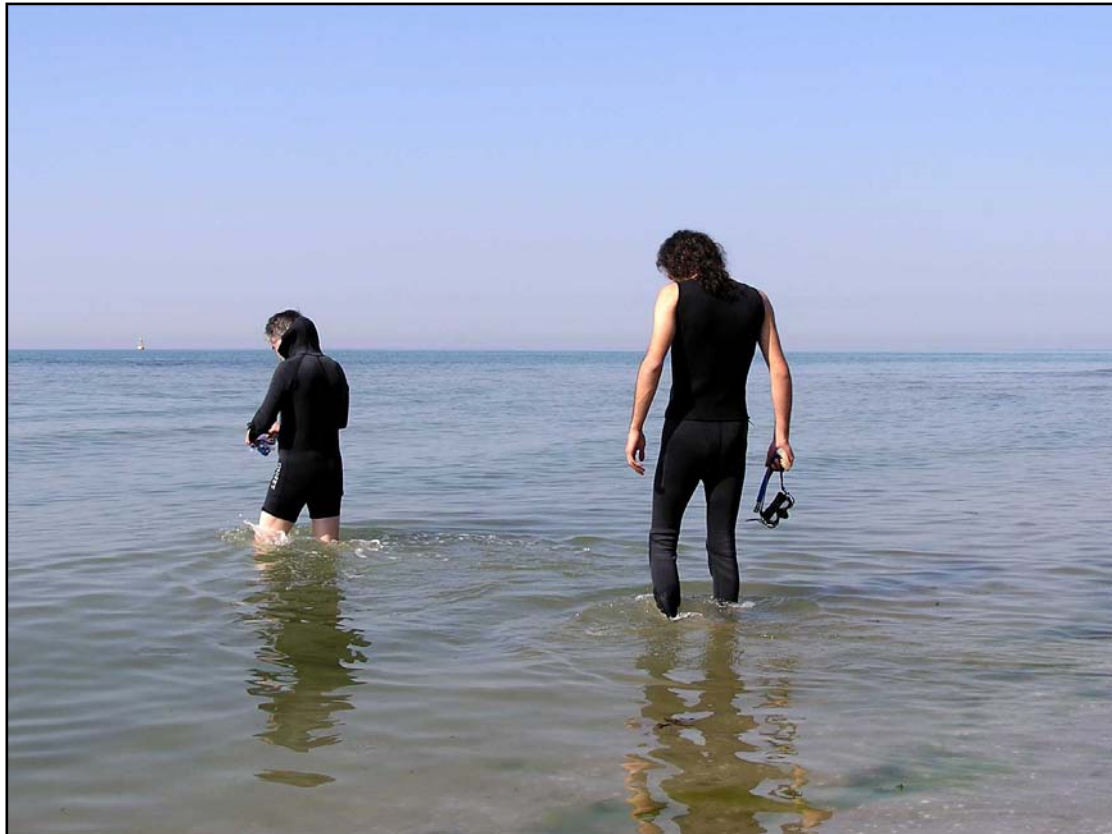
**Fig. 3. Silvri: James Crow and Evren Türkmenoğlu diving for the Anastasian Wall.**

In 2000 we carried out a brief survey with a total station of the submerged jetty or 'liman' at the south end of the Anastasian Wall. With the advice of Professor Nergis Gunsenin, and with the practical help of Evren Türkmenoğlu we were able to investigate these remains off the Altınorak beach. The underwater survey confirmed the basic V-shaped outline of the feature extending 200 m at right angles to the shore line. The 'liman' was made up from a compact mass of squared blocks encrusted with mussels. By clearing limited areas it was possible to show these were eroded limestone blocks, similar to those used in the construction of the Anastasian Wall.

Amongst the blocks were fragments of broken tiles and mortar with crushed brick typical of the construction of the Anastasian Wall, there can be little doubt that this feature represents the south end of the wall, similar to the *emboloi* described by Procopius for the wall at Gallipoli. On the beach there was a clear spread of building material, stones and tiles continuing this line inland to the north-east where traces of the Anastasian Wall were located by Türan Gökyıldırım of the Istanbul Archaeological museum on the hillside above.

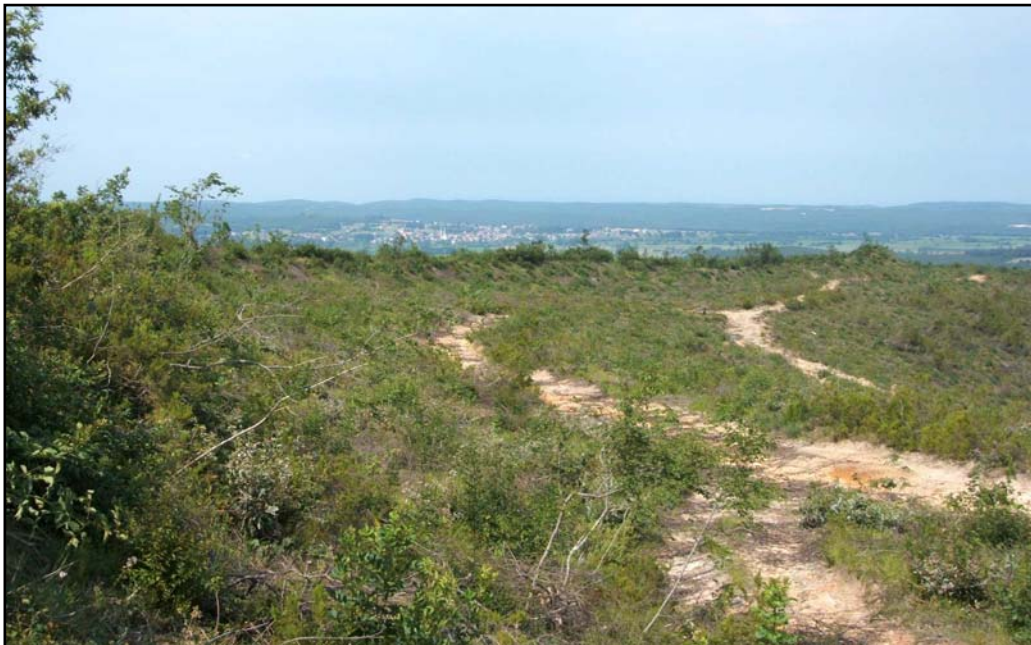
The forest clearance in the vicinity of Nikol Dere (see below) exposed a 1 km length section of the Anastasian Wall descending the ridge in the direction of the wide valley of the Binkiliç Dere. The wall survived as a 3 m high bank with one to two course of facing blocks visible in places.

**Fig. 5. The Anastasian Wall above Nikol Dere. The wall is visible as an embankment and dark green line of trees running along the ridge in the middle ground.**

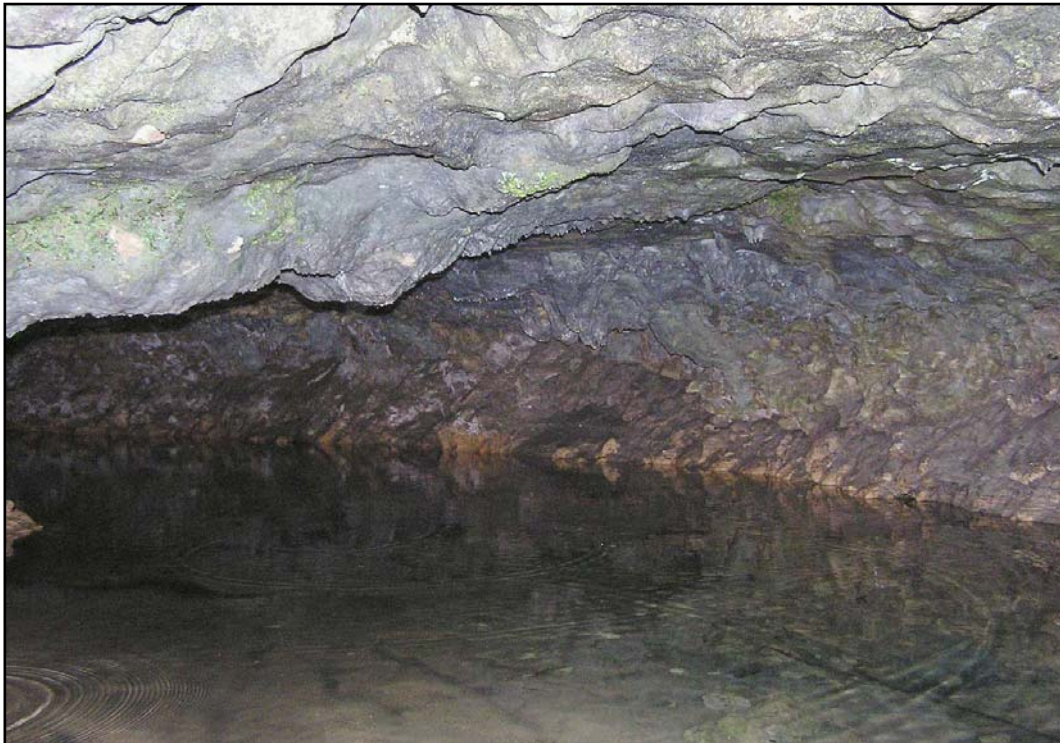
Fieldwork on the water supply system was limited to revisiting Pınarca and to sites located in the villages of Belgrat and Ciftlikköy. The three springs at Pınarca are located 2.5 km south-east of the Anastasian Wall. Clearance in the narrow valley of the Tek Göz Mağara showed more clearly that the sides were walled up, suggesting that the channel may have been damned to serve as a reservoir. We were also shown additional channels leading to a third cave and spring source (Fig. 6), reinforcing the importance of Pınarca as a major source for the first phase of the long-distance water supply system.

**Fig. 6. Cave and spring at Pınarca.**

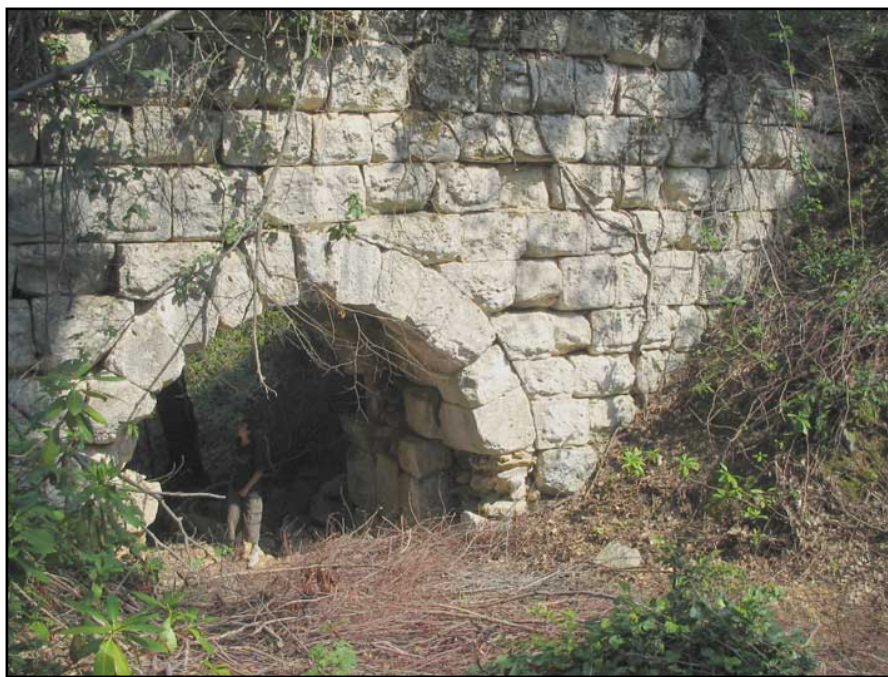
**Fig. 7. Nikol Dere; upper bridge.**

The upper bridge was single arched and well preserved (Fig. 7). It clearly carried a broad channel and at the north end the tunnel could be followed and seen to turn to the north-west. This is against the line of the contours. Below this was seen the more ruined remains of a second bridge with a single arch, and constructed with long bossed blocks, different from the equilateral blocks in the top bridge. Below the second bridge was a third bridge, this was more ruined than either of the other two and was constructed with large schist rubble work. A number of the features in the Nikol Dere are unique but can be summarised as follows: the primary bridge was the middle bridge, this conforms with the pattern of high-level bridges, clearly seen last year in the Maçka Dere, close-by. The second phase broad channel can be expected at a lower elevation, in the site occupied by the bridge of schist block-work. The equivalent bridge in the Maçka Dere was also extensively rebuilt, but did retain traces of earlier work. At the Nikol Dere however the lower bridge appears to be completely rebuilt probably in the middle Byzantine period.

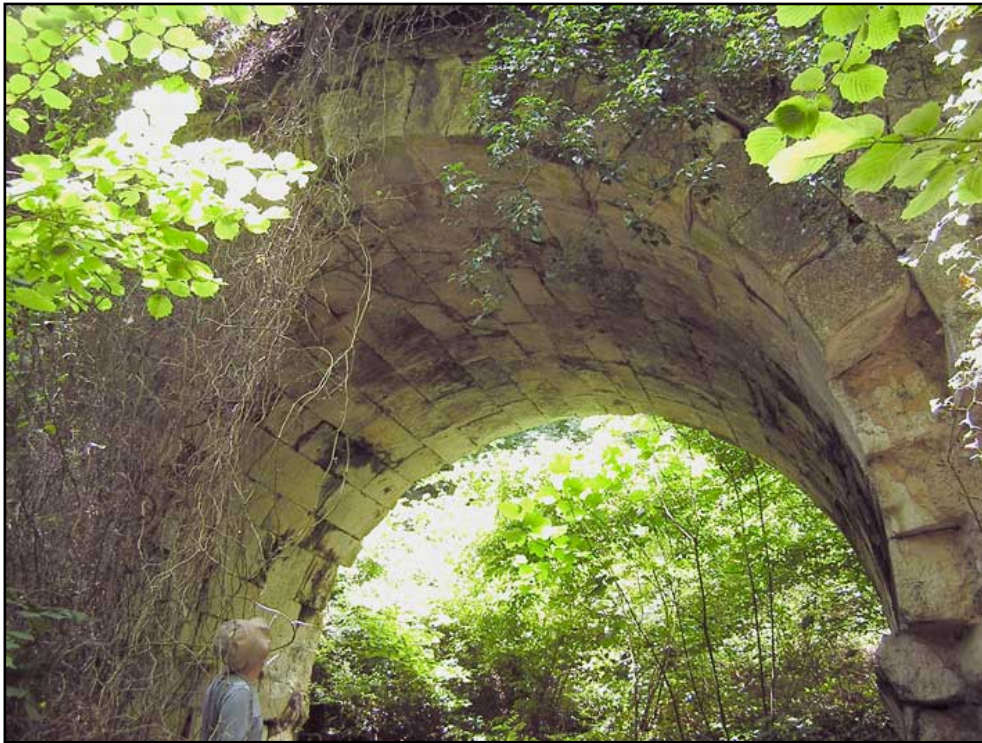
This bridge (K 25) was illustrated but not described Prof. Çeçen (1996, 175) and is situated west of Heyliye Tepe, in the district of Ciftlikköy (Fig. 8). The bridge has a well preserved single arch 5.54 wide and two buttresses on the north (downstream) side, the stringcourse was preserved on the south side and was of the distinctive downward chamfer seen at Talas and Leylekkale. This work is characteristic of the major restoration associated with the Longinus inscription and the two examples visited this year provide us with further evidence that almost all the known bridges of the main second phase (fifth century) were extensively rebuilt in the sector from Elkafdere in the west to Büyükgerme in the east, possibly the result of very specific seismic damage during Justinian's reign. The only exception is the distinctive bridge at Luka Dere (K 17), this has similar structural features, buttresses and string courses, and is probably also sixth century in date but represents the single restoration of a bridge further to the west.

**Fig. 8. Cevizlikkale bridge.**
